Historic Structures Report
Renwick Courthouse, Wallace Library, and Old Jail
City of Fredericksburg, Virginia

Created / Last Revised:
19 April 2016/ 15 June 2016

Prepared by:
Bryan Clark Green, Ph.D.
Commonwealth Architects
101 Shockoe Slip, Third Floor
Richmond, Virginia 23219

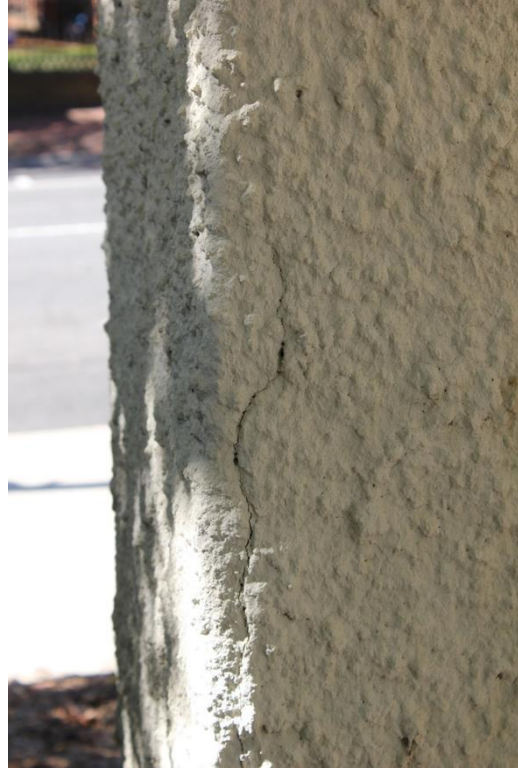
- Persistent moisture infiltration through hairline cracks in the Portland cement textured stucco (Fig. 1.1).
- Significant damage to and stress upon structural members (Figs. 1.2, 1.3).
- Chronic moisture infiltration in the bell tower (Fig. 1.4).

Figure 1.1, Renwick Courthouse, detail of exterior stucco. Note hairline cracks that result in moisture infiltration. Photograph 2015.

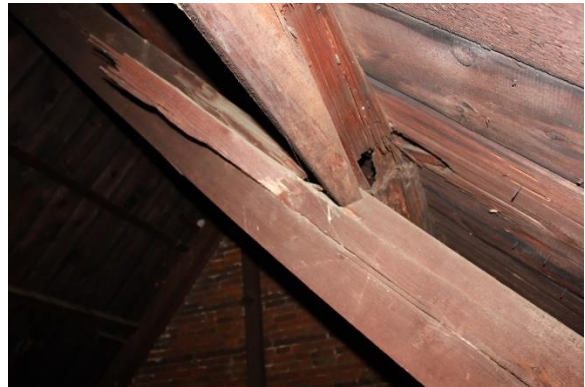
Figure 1.2, Fredericksburg Courthouse, North attic. Shifting of and damage to structural members. Photograph 2015.

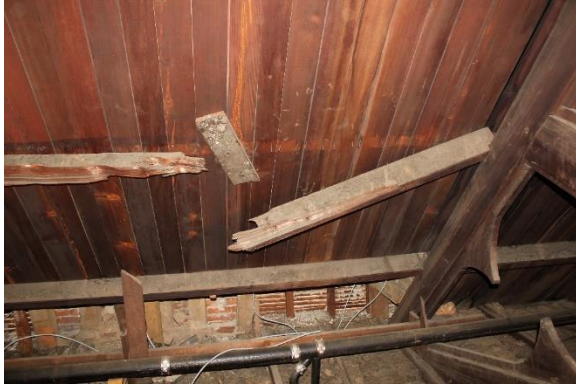
Figure 1.3, Fredericksburg Courthouse, North attic. Broken truss. Photograph 2015.

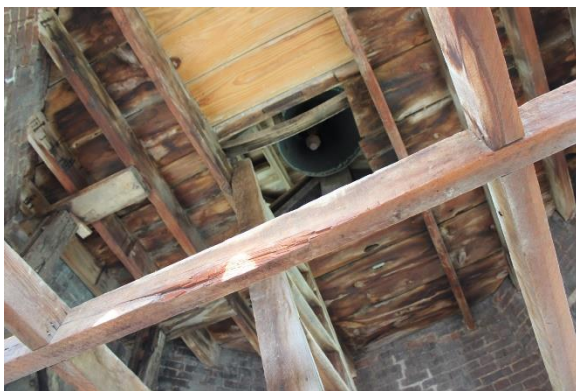
Figure 1.4, Fredericksburg Courthouse, bell tower. Moisture infiltration into the bell tower. Photograph 2015.

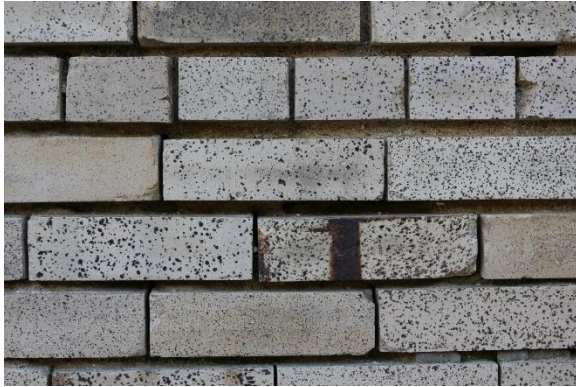
- Significant loss of mortar on the north elevation (Fig. 1.9).
- Persistent moisture infiltration into the basement level (Fig. 1.10).

Figure 1.9, Wallace Library. Extensive mortar loss in the north elevation. Photograph 2015.

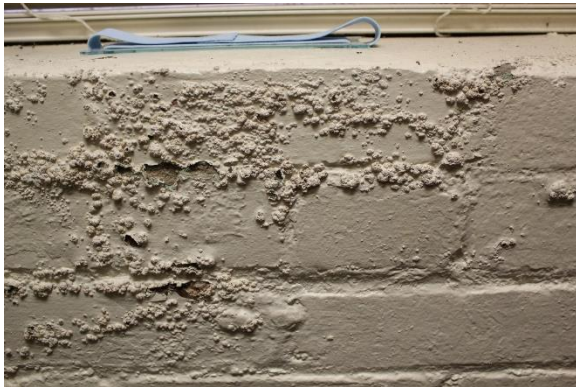
Figure 1.10, Wallace Library. Persistent moisture infiltration in the basement. Photograph 2015.

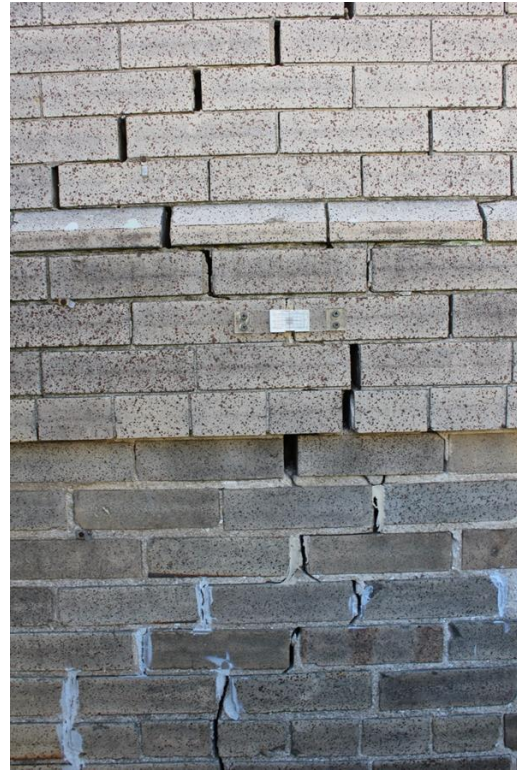
- Shifting and cracking of the brick at the north elevation, a situation related to loading issues on the basement wall created by the excavation of the basement (Fig. 1.11).

Figure 1.11, Wallace Library. Pervasive shifting and cracking of brick in the north elevation. Photograph 2015.

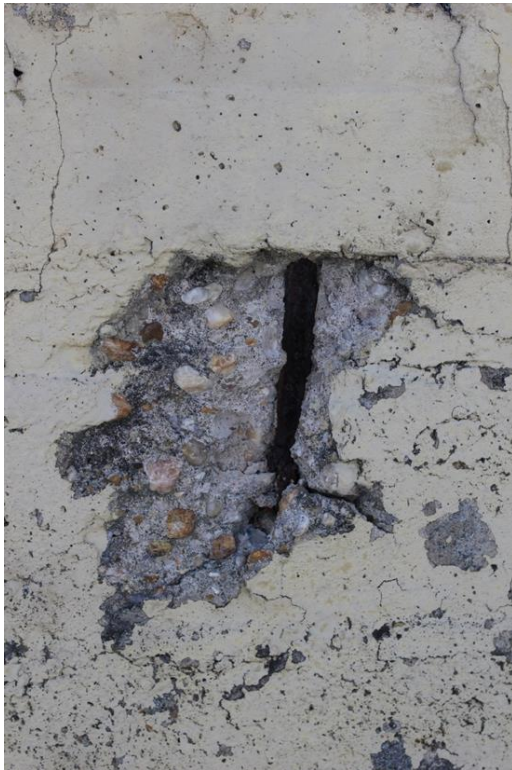
- Spalling, rust-jacking, and cracking of the exterior concrete walls (Figs. 1.15, 1.16).
- Lack of functional windows (Fig. 1.17).
- A roof nearing the end of its lifespan (Fig. 1.18).

Figure 1.15, Old Jail. Rust-jacking and spalling of the exterior concrete wall surfaces. Photograph 2015.

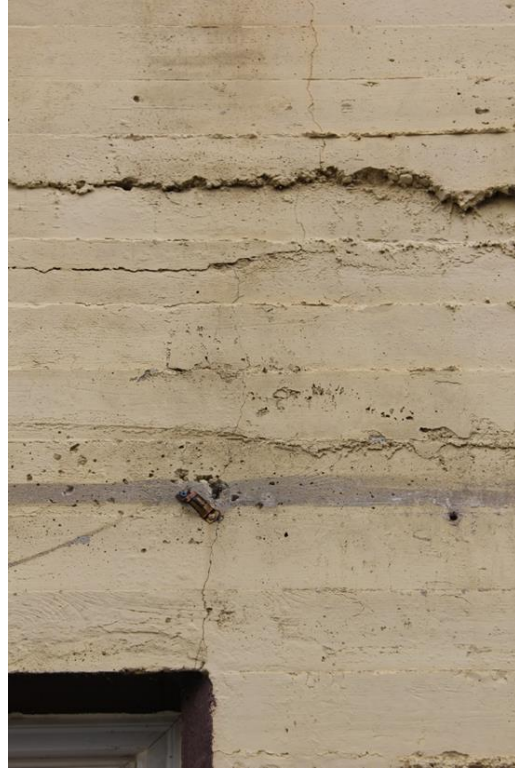
Figure 1.16, Old Jail. Cracking of the exterior concrete wall surfaces. Photograph 2015.

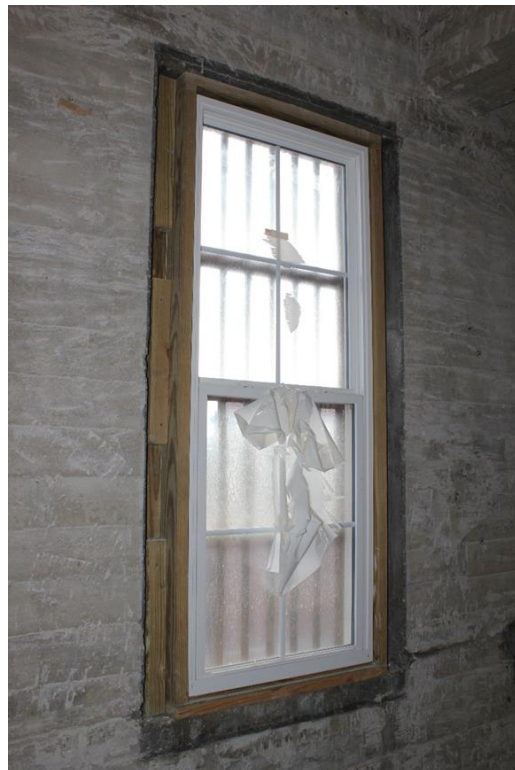
Figure 1.17, Old Jail. Nonfunctional window. Photograph 2015.

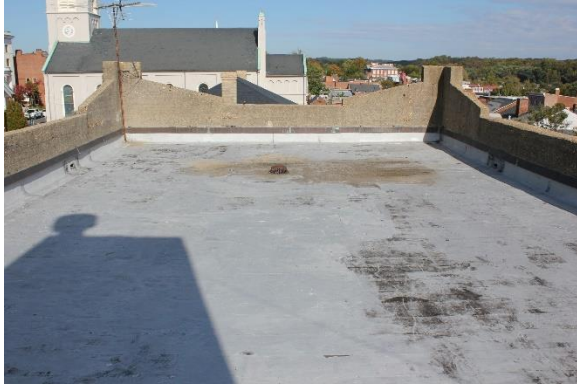
Figure 1.18, Old Jail roof, which is nearing the end of its expected lifespan. Photograph 2015.

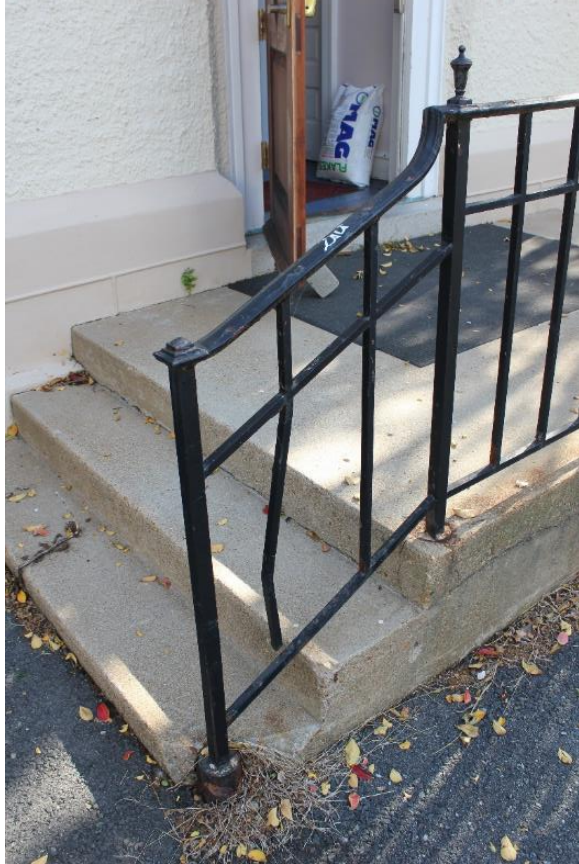
Figure 3.21, Historic Renwick Courthouse, north elevation, view of concrete steps; note the rust and the bent baluster.

A set of concrete steps with two side flights and a metal rail leads to the entry. The rail is rusted and one of the balusters is bent.

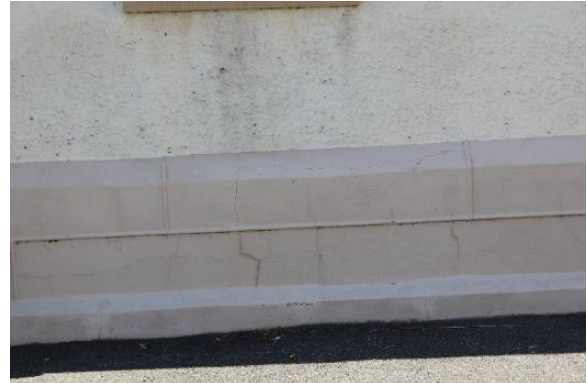
Figure 3.25, Historic Renwick Courthouse, east elevation, detail view of foundation. Note the extruded mortar joints and the vertical crack.

There is a stone foundation with extruded mortar joints, cracked in some locations.

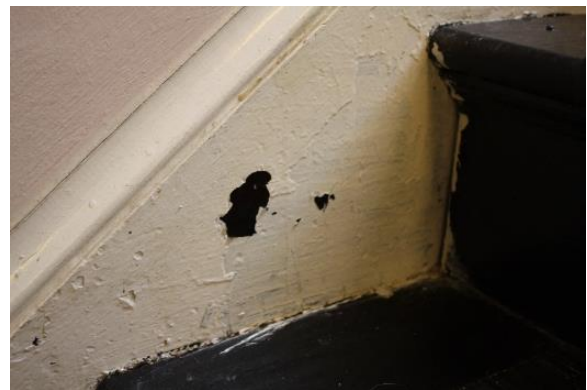
Figure 3.47, Historic Courthouse, First Floor, Room 101, view of paint loss at stairway stringer.

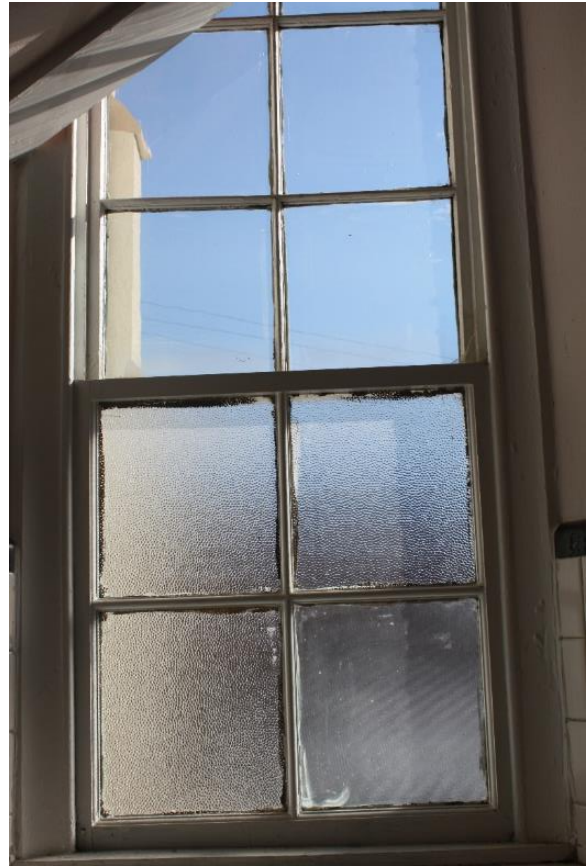
Windows:
The east wall contains one wood six-over-four, hung window with a pointed head and privacy glass at the bottom sash. There is some stray paint at the panes. It has narrow, flat wood trim and is set in an opening with flared reveals. The sloping ceiling partially covers the head.

Figure 3.48, Historic Courthouse, First Floor, Room 102, view of window with privacy glass and stray paint at the panes.

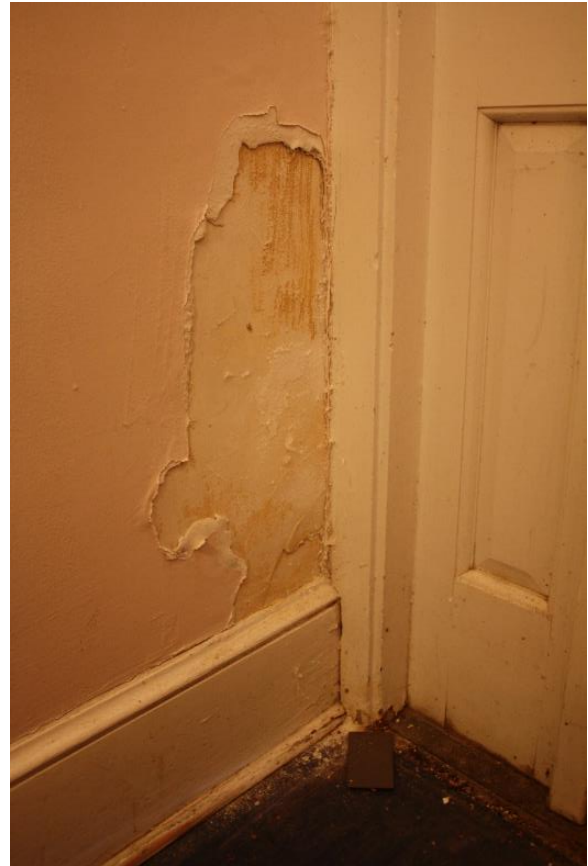
Figure 3.50, Historic Courthouse, First Floor, Room 102, view of efflorescence at the plaster walls near the exterior door.

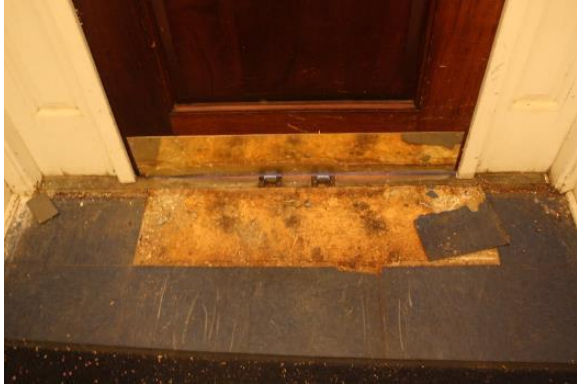
Figure 3.51, Historic Courthouse, First Floor, Room 103, view broken and missing floor tiles.

The floor is square vinyl composition tile. There is a strip of broken or missing tiles near the door threshold, likely due to water infiltration.

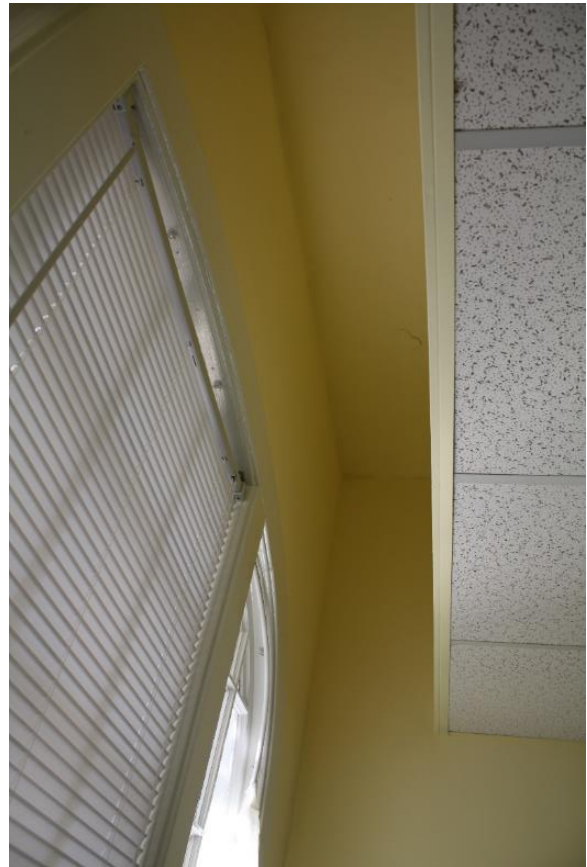
Figure 3.53, Historic Courthouse, First Floor, Room 105, view of high plaster ceiling and suspended acoustical tile ceiling.

The ceiling is covered with suspended acoustical tile. The plaster ceiling above is visible adjacent to the window; this ceiling has a small crack.

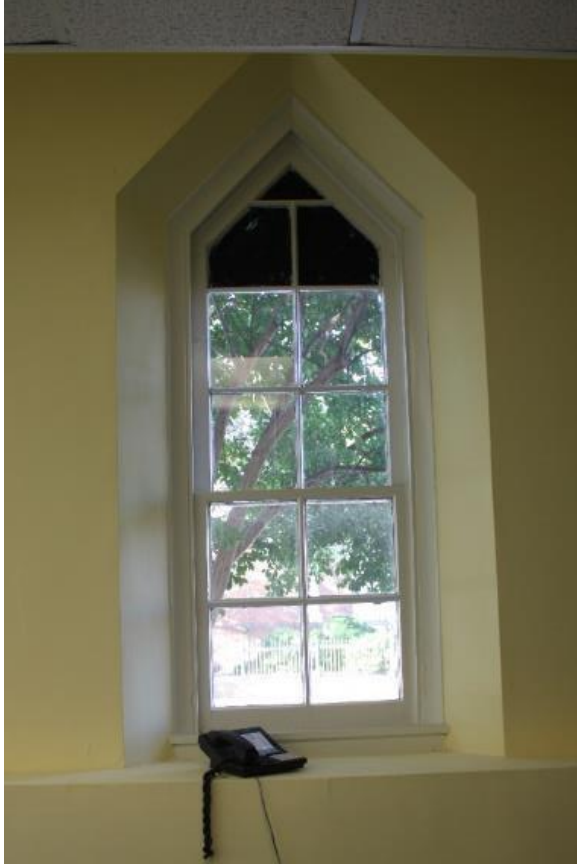
Figure 3.56, Historic Courthouse, First Floor, Room 106, view of window at the west wall with paint at the top panes.

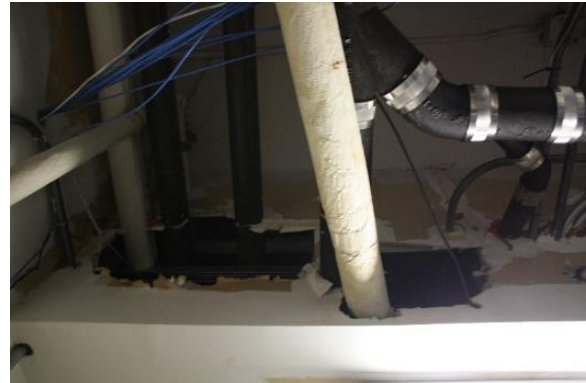
Figure 3.60, Historic Courthouse, First Floor, Room 108, view of holes cut in drywall for pipes.

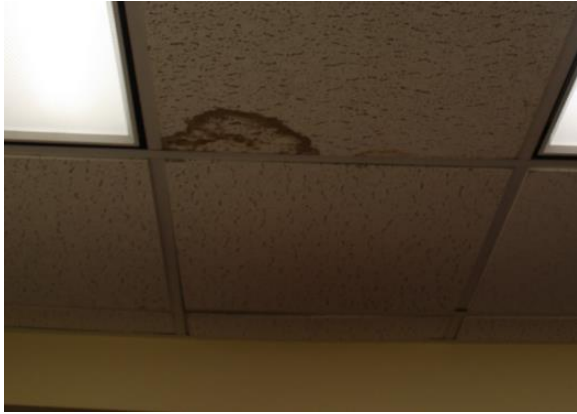
The ceiling is suspended acoustical tile, some of which exhibit moisture staining.

Figure 3.63, Historic Courthouse, First Floor, Room 112, view of moisture staining at the ceiling toward the center of the room.

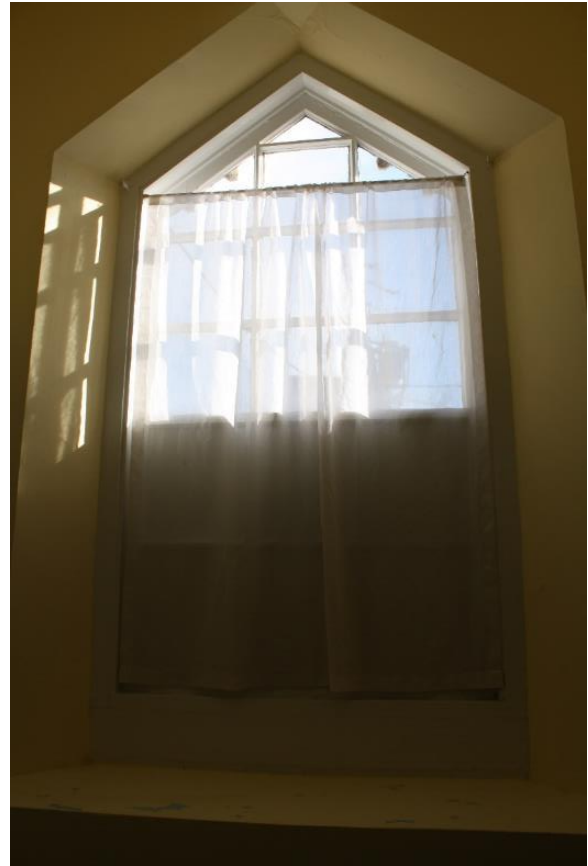
Figure 3.65, Historic Courthouse, First Floor, Room 114, view of window; the bottom panes are painted over.

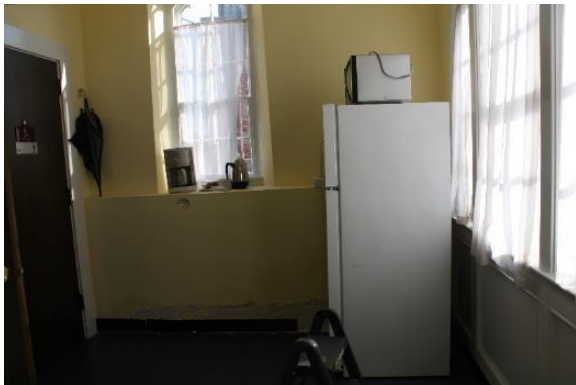
Figure 3.66, Historic Courthouse, First Floor, Room 115, general view looking east. Note the plaster damage toward the base of the wall and missing sections of the vinyl base.

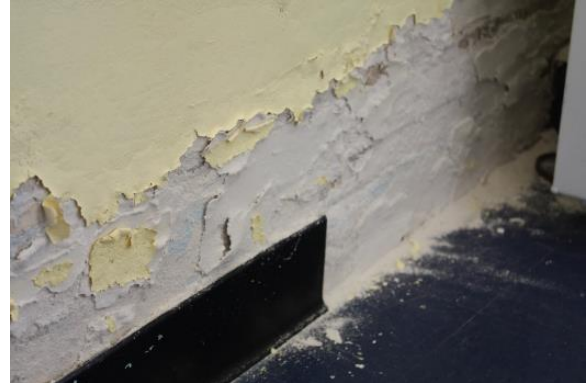
Figure 3.67, Historic Courthouse, First Floor, Room 115, view of damaged plaster and missing base at the east wall.

The east and south walls are of plaster and the north and west walls are of gypsum board. All walls have a vinyl base. There is a built-in ledge at the east wall. The east wall is heavily damaged along the base, and there are missing sections of the base in this area. A large hole is located underneath the east window.

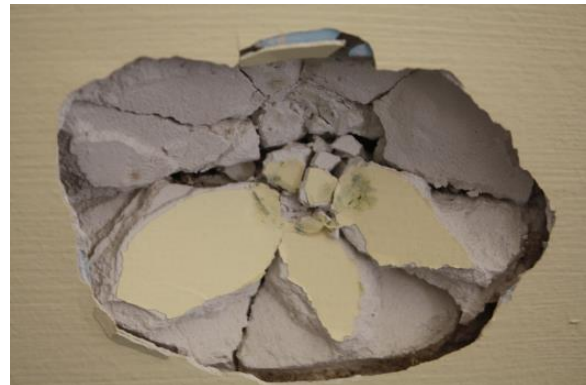
Figure 3.68, Historic Courthouse, First Floor, Room 115, view of hole in east plaster wall.

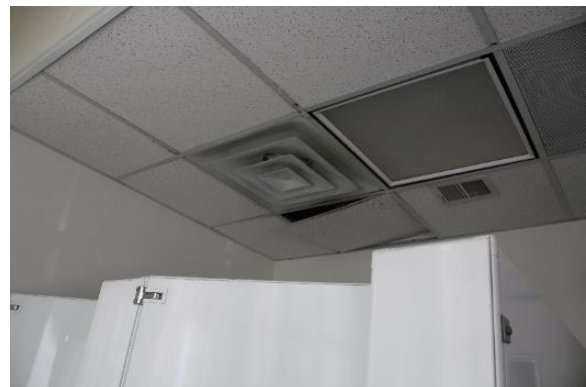
Figure 3.70, Historic Courthouse, First Floor, Room 116, view of the ceiling; note the displaced ceiling tile.

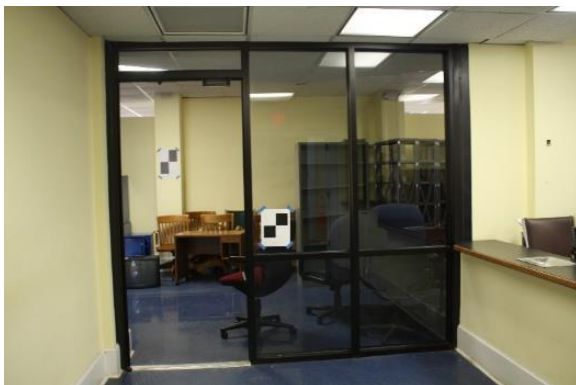
Figure 3.77, Historic Courthouse, First Floor, Room 118, view looking east at the storefront windows; note the missing door at left.

At the west wall, paneled wood double doors lead to the main entry (Room 119). Each leaf has one tall, one-light rectangular window over two horizontal panels. Hardware consists of three butt hinges and a door closer at each leaf and a push plate with deadbolt at the south leaf. The doors are set in a deep opening with narrow, molded wood trim. There is a doorway at the east storefront windows that is now missing a door.

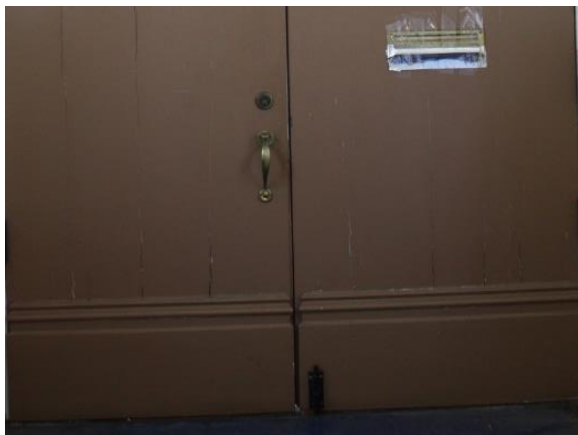
Figure 3.82, Historic Courthouse, First Floor, Room 119, detail view of vertical cracks at base of doors.

The double entry doors at the west wall are contained within a pointed-arch, flat wood surround. The doors are flat, painted wood with molded wood bases. There are large vertical cracks toward the base of each door. Hardware consists of a pull handle with thumb latch, a key lock and deadbolt, an extension bolt, and three butt hinges at each leaf.

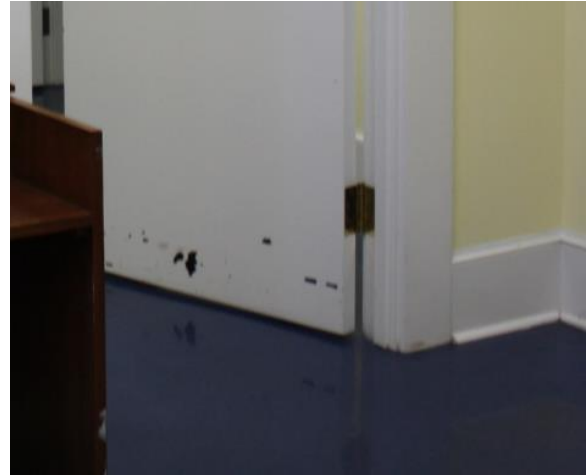
Figure 3.85, Historic Courthouse, First Floor, Room 120, view of paint loss at the base of the north door.

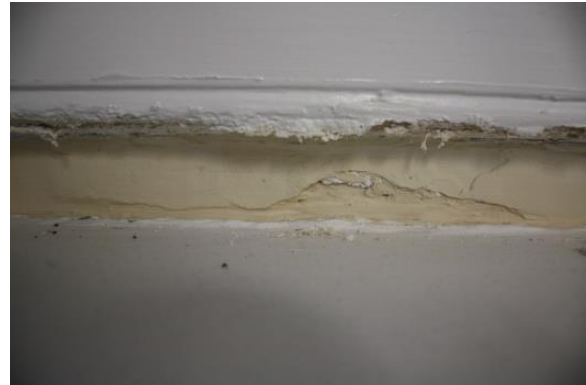
Figure 3.92, Historic Courthouse, First Floor, Room 123, view of plaster damage underneath the apron of the west window of the north wall.

The walls are of plaster and have a molded wood chair rail and baseboard. There are small, squared projections to either side of the built-in bookshelf at the east wall. Just above the chair rail, there is a built-in ledge at the north and west walls. Underneath the west window at the north wall, there is some plaster damage, including a small area between the apron and chair rail and a large area under the chair rail.

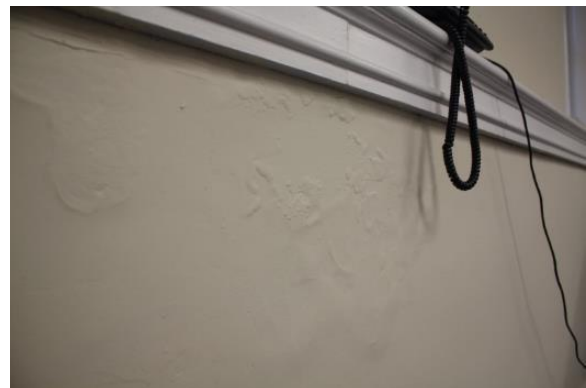
Figure 3.93, Historic Courthouse, First Floor, Room 123, view of plaster damage underneath the west window of the north wall.

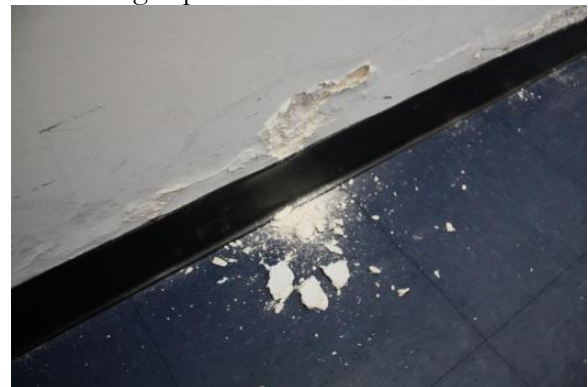
Figure 3.105, Historic Courthouse, First Floor, Room 128, detail view of plaster damage and efflorescence at east wall.

The walls are of plaster. “This room lacks the molded wood baseboard found throughout many of the first floor rooms and consists of a vinyl base trim. A built-in ledge runs along the east and south walls. Along the base of the east and south walls, there is significant plaster damage and efflorescence. There are several long, vertical cracks at the south wall near the southwest corner.

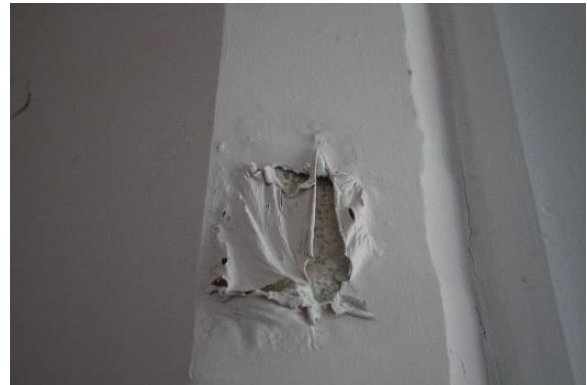
The walls are of plaster and have a wood base with shoe and cap molds. There are several areas of paint failure due to moisture, including one significant area between the windows at the north wall.

Figure 3.114, Historic Courthouse, First Floor, Room 132 (Stairway 2), view of paint failure due to moisture at the reveal of the window at the east wall.

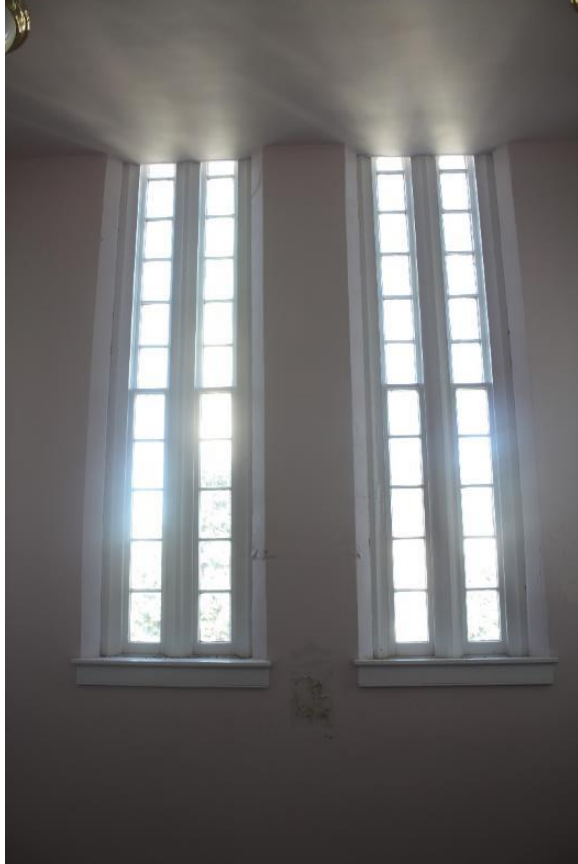
Figure 3.115, Historic Courthouse, First Floor, Room 132 (Stairway 2), view of windows at north wall of stair landing. Note the truncated heads of the windows.

At the stair landing are two tall, narrow wood windows, each with two tall, six-over-five lancet-shaped hung sash. Each window has flat, narrow wood trim including a simple apron. The head of each window is truncated by the ceiling. There is minor damage at both wood frames.

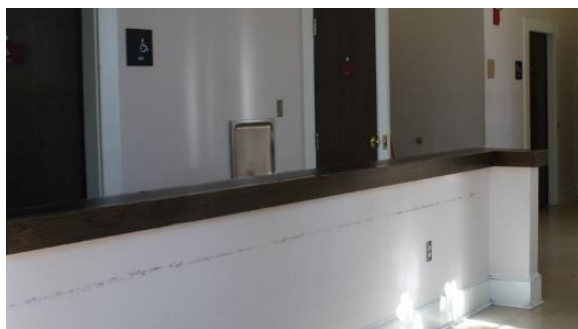
Figure 3.123, Historic Courthouse, Second Floor, Room 202, detail view of horizontal scuff marks at north low wall.

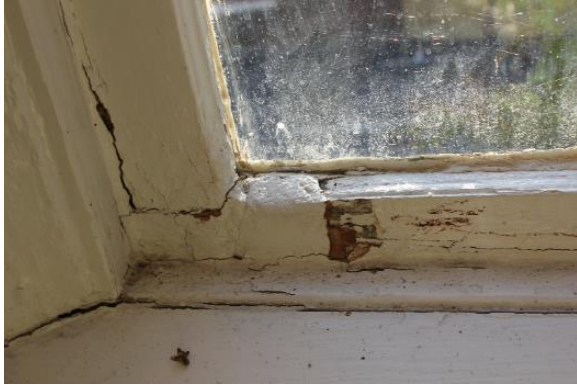
Figure 3.125, Historic Courthouse, Second Floor, Room 202, view of wood deterioration and cracking at a window frame.

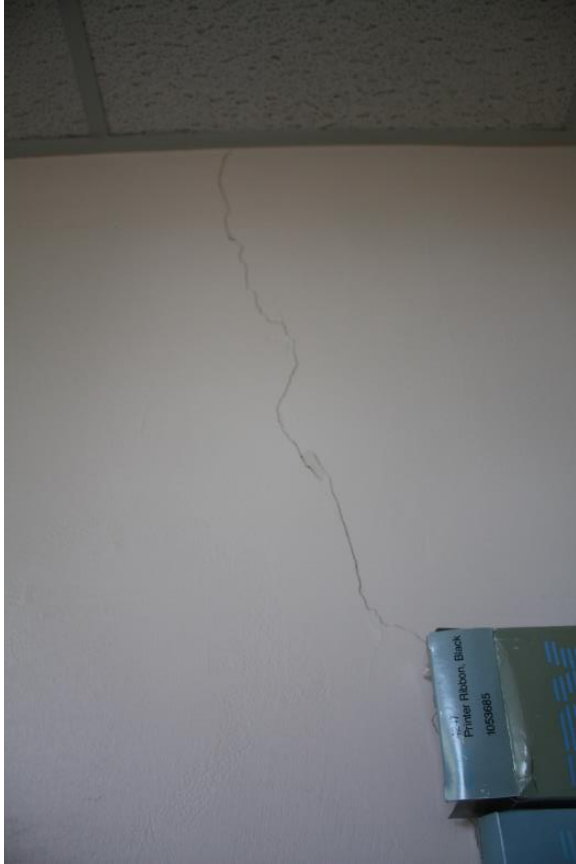
The north and west walls are of plaster and the east and south walls are of gypsum board; all walls have a vinyl base. A shallow ledge capped with wood is built into the west and north walls. There is a vertical crack in the plaster at the north wall near the northeast corner of the room.

Figure 3.127, Historic Courthouse, Second Floor, Room 203, detail view of crack at the north wall.

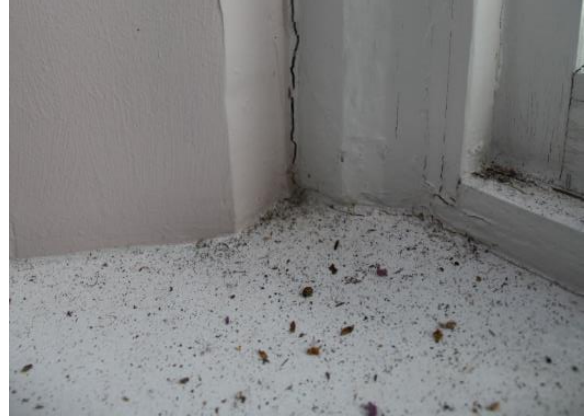
Figure 3.129, Historic Courthouse, Second Floor, Room 203, view of northernmost window at west wall; note the heavily-soiled sill and separation between the reveal and frame.

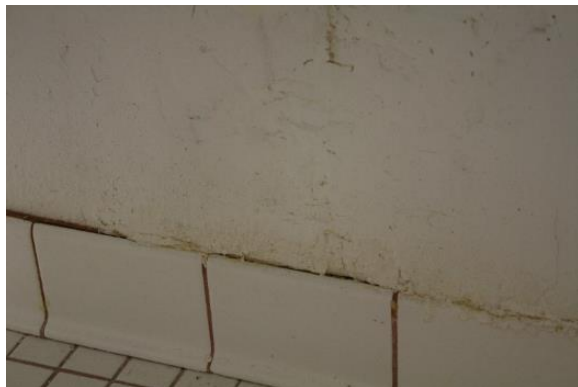
Figure 3.131, Historic Courthouse, Second Floor, Room 204, view of damage to south wall under urinal.

The walls are of gypsum board, except for the west end of the north wall, which is of plaster. All walls have a ceramic tile base. There is an area of damage near the base of the wall under the urinal.

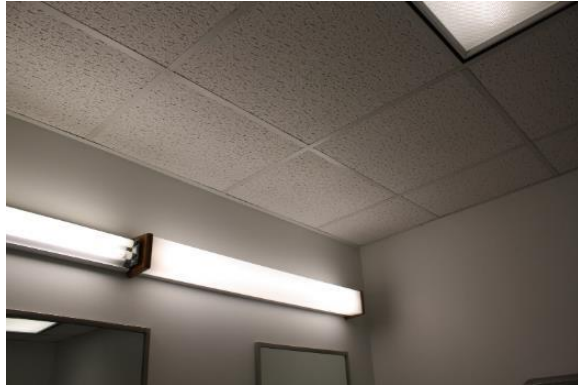
Figure 3.134, Historic Courthouse, Second Floor, Room 206, view of ceiling and lights above sink at the west wall; note the missing light cover at left.

There is a fluorescent panel at the ceiling and two fluorescent light strips above the mirror. One of the strips is missing its cover.

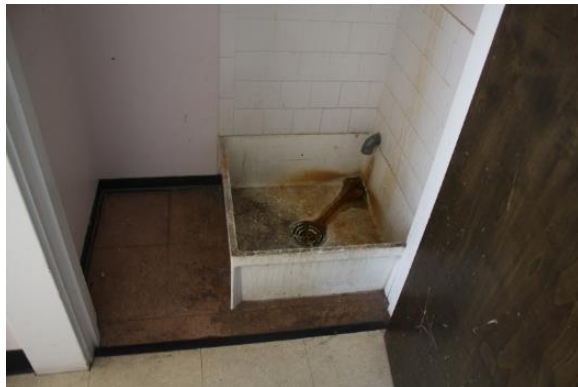
Figure 3.136, Historic Courthouse, Second Floor, Room 207, view of mop sink. Note heavy soiling and rust at both sink and tile and soiled floor.

A floor-mounted mop sink is located at the north end of the closet. The sink is heavily soiled and rusted.

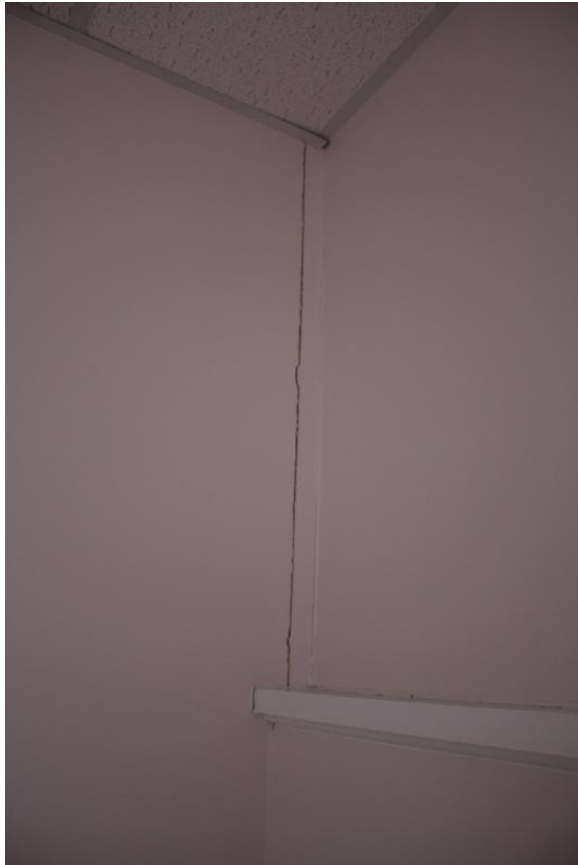
Figure 3.138, Historic Courthouse, Second Floor, Room 208, view of crack at northwest corner of the room.

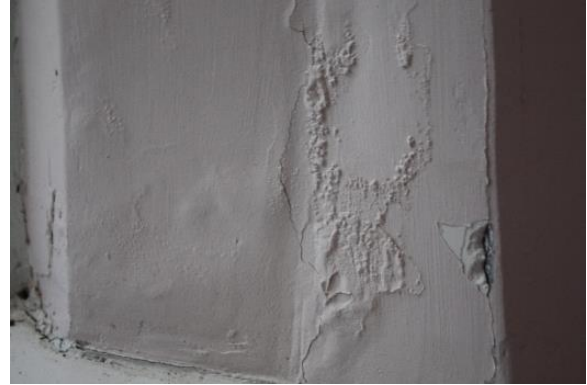
fourteen-over-twelve light hung sashes. There are wood cutouts at the window to imitate smaller, pointed-head sashes. The other window is the lower part of a large, wood window with pointed head and a single, twelve-over-ten hung sash. The plaster window reveals exhibit water damage.

Figure 3.139, Historic Courthouse, Second Floor, Room 208, view of plaster damage at one of the window reveals.

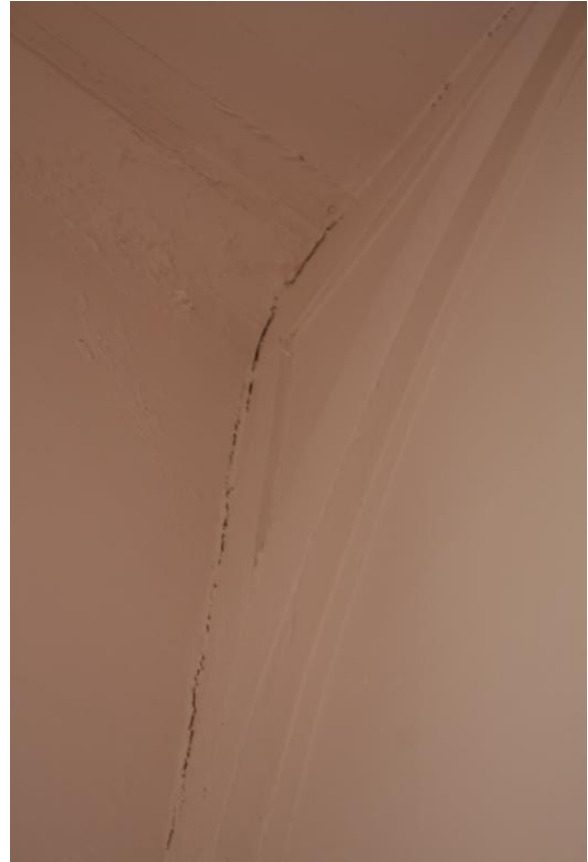
Figure 3.143, Historic Courthouse, Second Floor, Room 211, view of west brace separating from the wall.

west wall at the intersection of the south wall and the ceiling. The brace is separating slightly from the south wall.

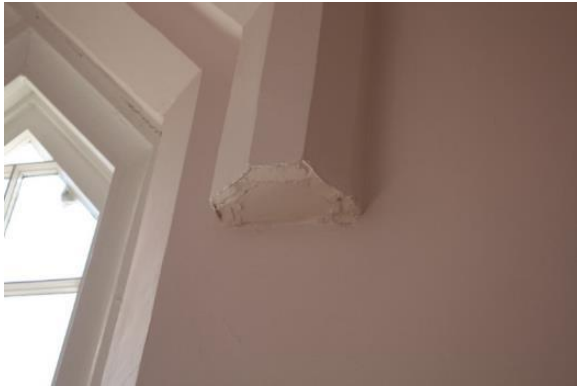
Figure 3.144, Historic Courthouse, Second Floor, Room 211, view of missing pendant at window hood mold.

There is one wood window with a pointed head at the south wall, containing two narrow, lancet-shaped, eight-over-six sash and a top, diamond-shaped light with four panes. The window has a pointed, cast plaster hood mold and is set in a deep opening with flared reveals and a wood sill. One of the decorative pendants at the hood mold is missing.

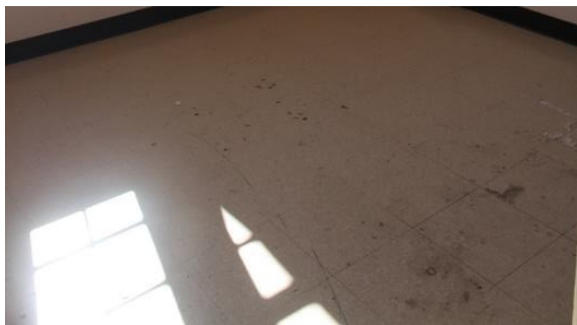
Figure 3.145, Historic Courthouse, Second Floor, Room 209, view of soiling and scuffing at floor.

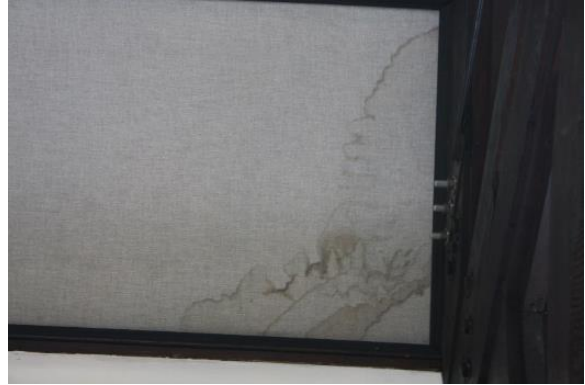
The vaulted plaster ceiling has exposed wood purlins running north-south and is covered with modern acoustic panels, some of which exhibit moisture staining. Along the length of the ceiling are six evenly-spaced, Gothic Revival-style wood hammer beam trusses. Each has a two collar braces forming a pointed arch and two arched hammer braces. There are pendants between the collar braces and hammer braces and pendant posts at either end of each truss.

Figure 3.150, Historic Courthouse, Second Floor, Room 212, view of moisture staining at the acoustic paneling.

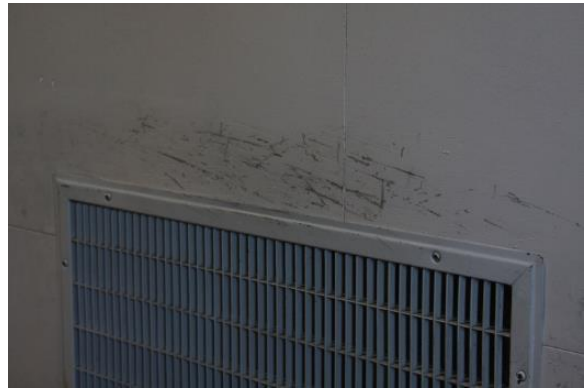
Figure 3.151, Historic Courthouse, Second Floor, Room 212, view of scratches above a vent at the north wall.

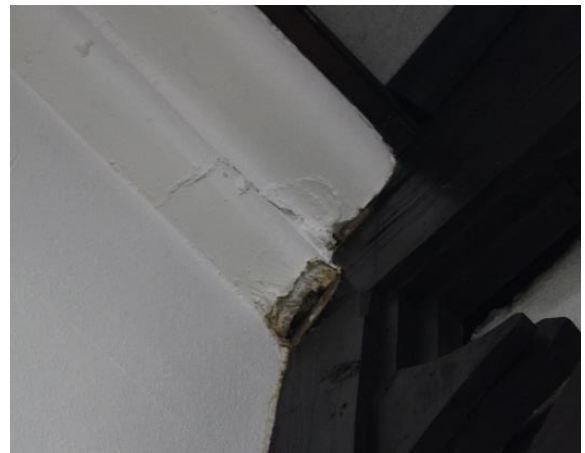
Figure 3.152, Historic Courthouse, Second Floor, Room 212, view of cracks at the crown molding in the southeast corner of the room.

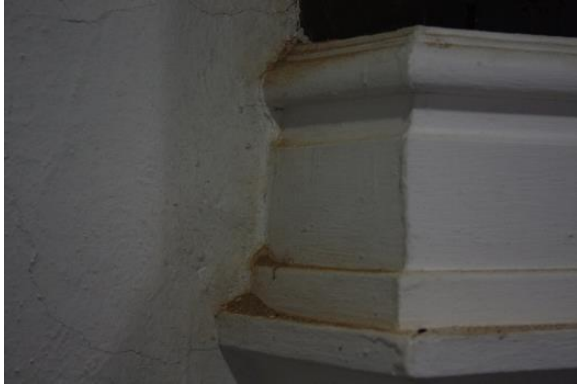
Figure 3.153, Historic Courthouse, Second Floor, Room 212, view of dust from masonry wall adjacent to a pendant post in the northwest corner of the room; this is evidence of efflorescence.

The walls are of plaster lightly scored in a pattern imitating ashlar masonry, with a narrow wood base and cap mold and a plaster crown molding. There is a molded wood chair rail at the north end of the room beyond the bar (the low wall that divides the audience area from the remainder of the courtroom). The south wall is finished with rectangular acoustic panels with a wood border in a stepped pattern nearly to the ceiling. At the north wall, there are scratches at the wall above the vent between the two easternmost doors. At the southeast corner of the room, there are cracks at the crown molding and streaks of moisture at the wall below. At a pendant post between the two northernmost windows of the west wall a reddish dust has accumulated, evidence of efflorescence from the interior masonry wall.

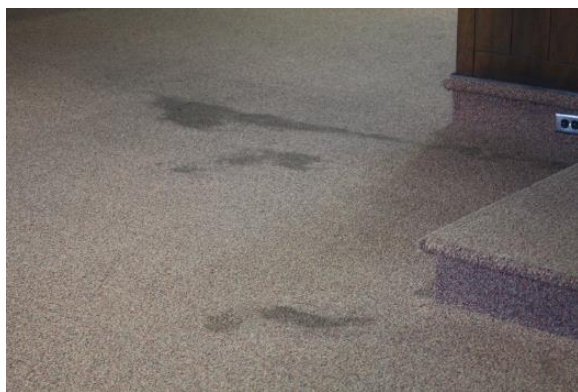
the north. There are stains at the carpet near the judge's bench.

Figure 3.156, Historic Courthouse, Second Floor, Room 212, view of stains at the carpet adjacent to the judge's bench.

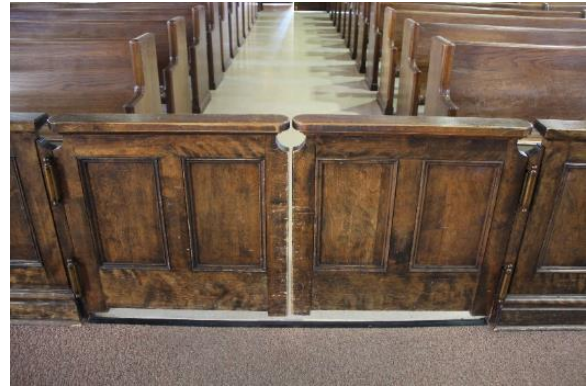
steps with six wood chairs mounted on each step, and is enclosed by a low, paneled wood wall slightly higher than the bar. The bar is also of paneled wood and has a pair of swinging doors at the center, which are heavily worn and scratched. The bar terminates at either end with a decorative wood bracket attached to a pendant post at the wall. The audience section at the north end of the room contains eleven rows of wood benches.

Figure 3.159, Historic Courthouse, Second Floor, Room 212, view of the swinging doors at the bar. Note the heavy wear and scratching where the doors meet.

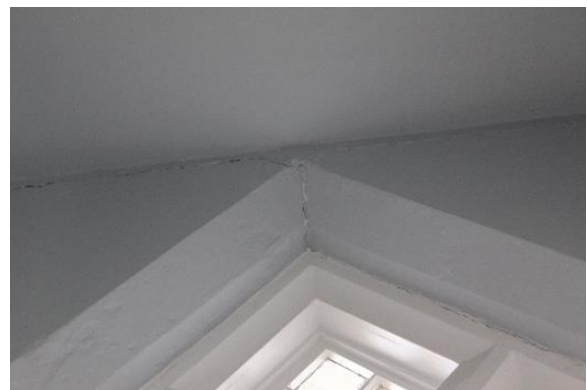
Figure 3.167, Historic Courthouse, Second Floor, Room 216, view of crack at head of window at north wall.

The walls are of plaster, except for the east wall, which is of gypsum board. All walls have a flat wood base with a top cove mold. There is a small crack at the head of the window of the north wall and a large area of efflorescence below the center window of the west wall.

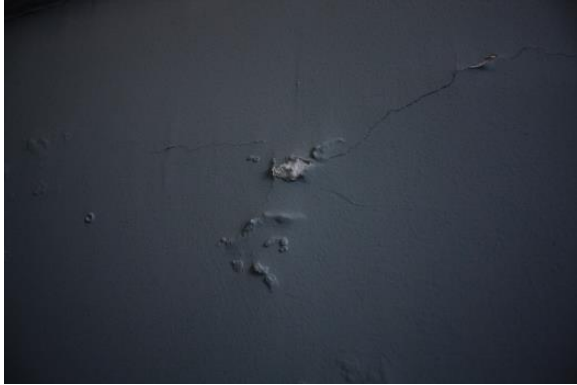
Figure 3.168, Historic Courthouse, Second Floor, Room 216, view of efflorescence below center window at west wall.

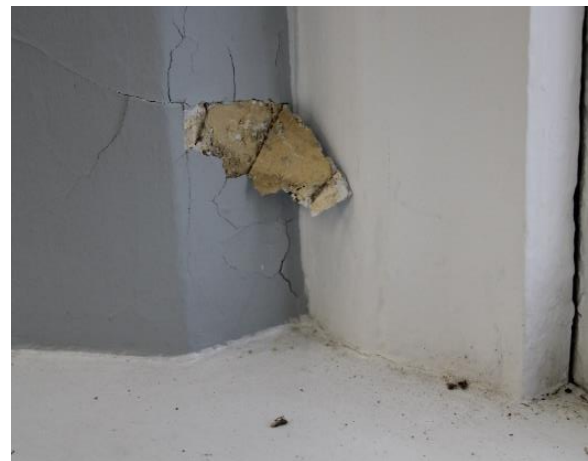
Figure 3.170, Historic Courthouse, Second Floor, Room 216, view of plaster damage due to efflorescence at the northernmost window of the west wall.

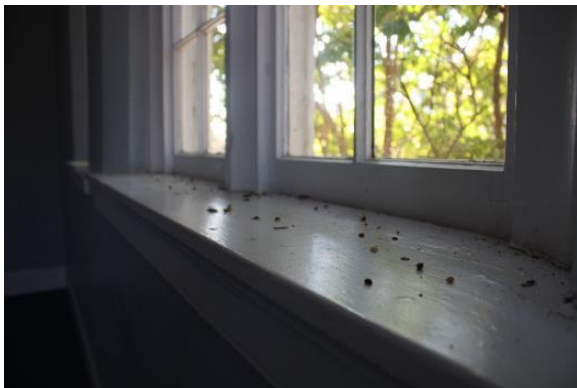
Figure 3.172, Historic Courthouse, Second Floor, Room 216, view of dead insects at sill of center window of west wall.

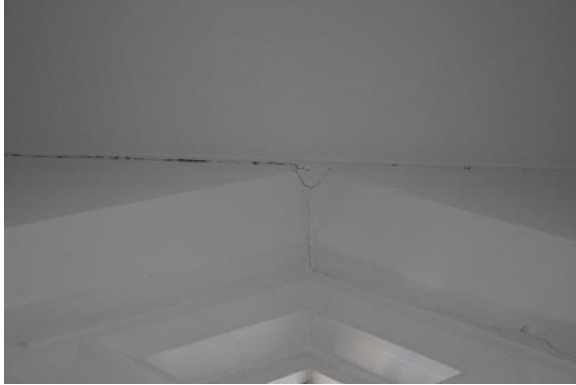
Figure 3.174, Historic Courthouse, Second Floor, Room 217, view of crack in plaster at head of window.

The walls are finished with ceramic tile halfway up. Above the tile, the north wall is of plaster and the remaining walls are of gypsum board. There is a crack in the plaster above the window.

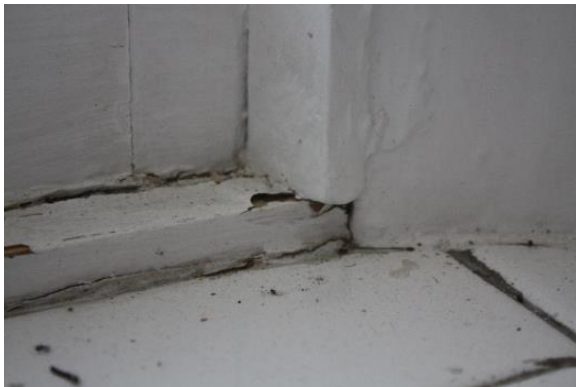
Figure 3.175, Historic Courthouse, Second Floor, Room 217, view of paint loss and damage at the wood window frame.

There is one wood window at the north wall, which is set in a deep opening with flared reveals and a pointed head. It has two narrow, lancet-shaped, eight-over-six hung sash with pointed heads and privacy glass. In between each sash is a diamond-shaped, four-light pane. The base of the wood frame exhibits a minor area of damage and paint loss.

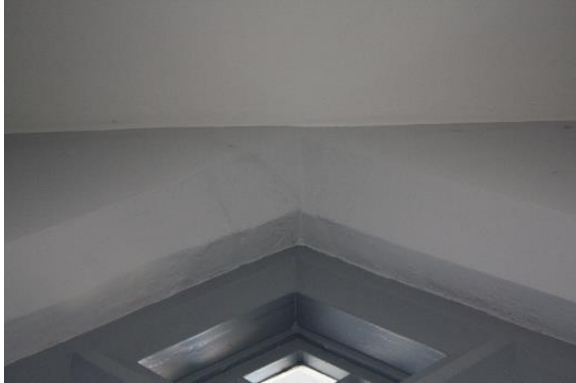
Figure 3.179, Historic Courthouse, Second Floor, Room 219, view of water damage at head of window.

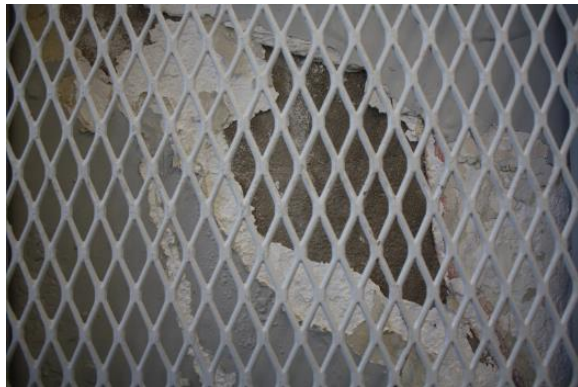
Figure 3.183, Historic Courthouse, Second Floor, Room 221, view of plaster damage due to efflorescence underneath the east window.

covered by metal grates, including windows and light fixtures. There is a significant area of plaster damage due to efflorescence underneath the east window. No baseboard is present.

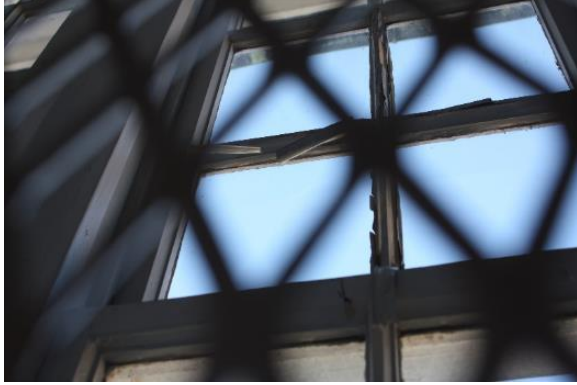
At the north wall is a wood window with a pointed head containing two narrow, lancet-shaped, eight-over-six sash and a top, diamond-shaped light with four panes. This window exhibits paint failure at the muntins. At the east wall, the lower part of a wood, lancet-shaped, multistory window with pointed head and twelve-over-ten hung sash is visible. It is truncated at the head by the plaster ceiling. Both windows are set in deep openings with flared reveals.

Figure 3.185, Historic Courthouse, Second Floor, Room 221, view of paint failure at the muntins of the north window.

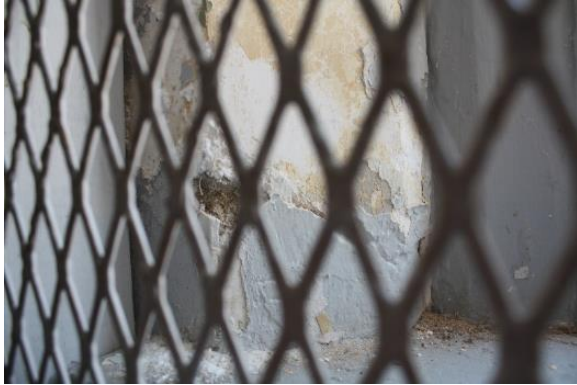
Figure 3.190, Historic Courthouse, Second Floor, Room 222, view of efflorescence and paint failure at a window reveal.

The reveals of both windows exhibit significant efflorescence and paint failure.

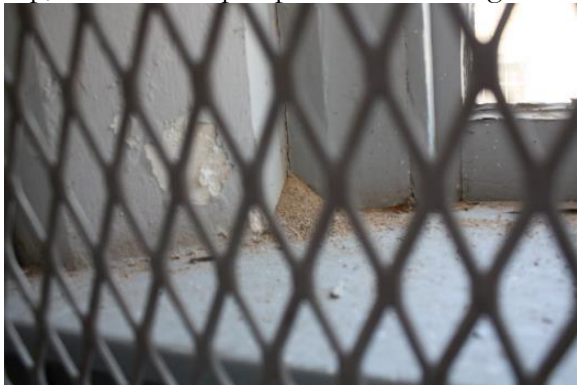
Figure 3.191, Historic Courthouse, Second Floor, Room 222, view of efflorescence and paint failure at a window reveal.

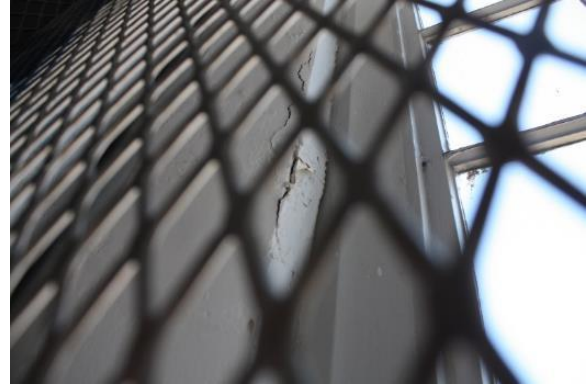
The east wall is of plaster and the remaining walls are of gypsum board. Except for the floor, the entire room is covered by metal grates, including windows and light fixtures. There is a vertical crack at the north reveal of the northernmost window. No baseboard is present.

Figure 3.192, Historic Courthouse, Second Floor, Room 222, view of a crack at the reveal of the north window.
